# Doosan L136T Diesel Engine Vibrometry

Óscar R. Enríquez, PhD  
Eduardo Margallo, PhD

UNIVERSIDAD  
POLITÉCNICA  
DE MADRID

**Doosan L136T** diesel engine tested at ~800 rpm, 1300 rpm and 1900 rpm; installed at the School of Naval Engineering (UPM) test bench.

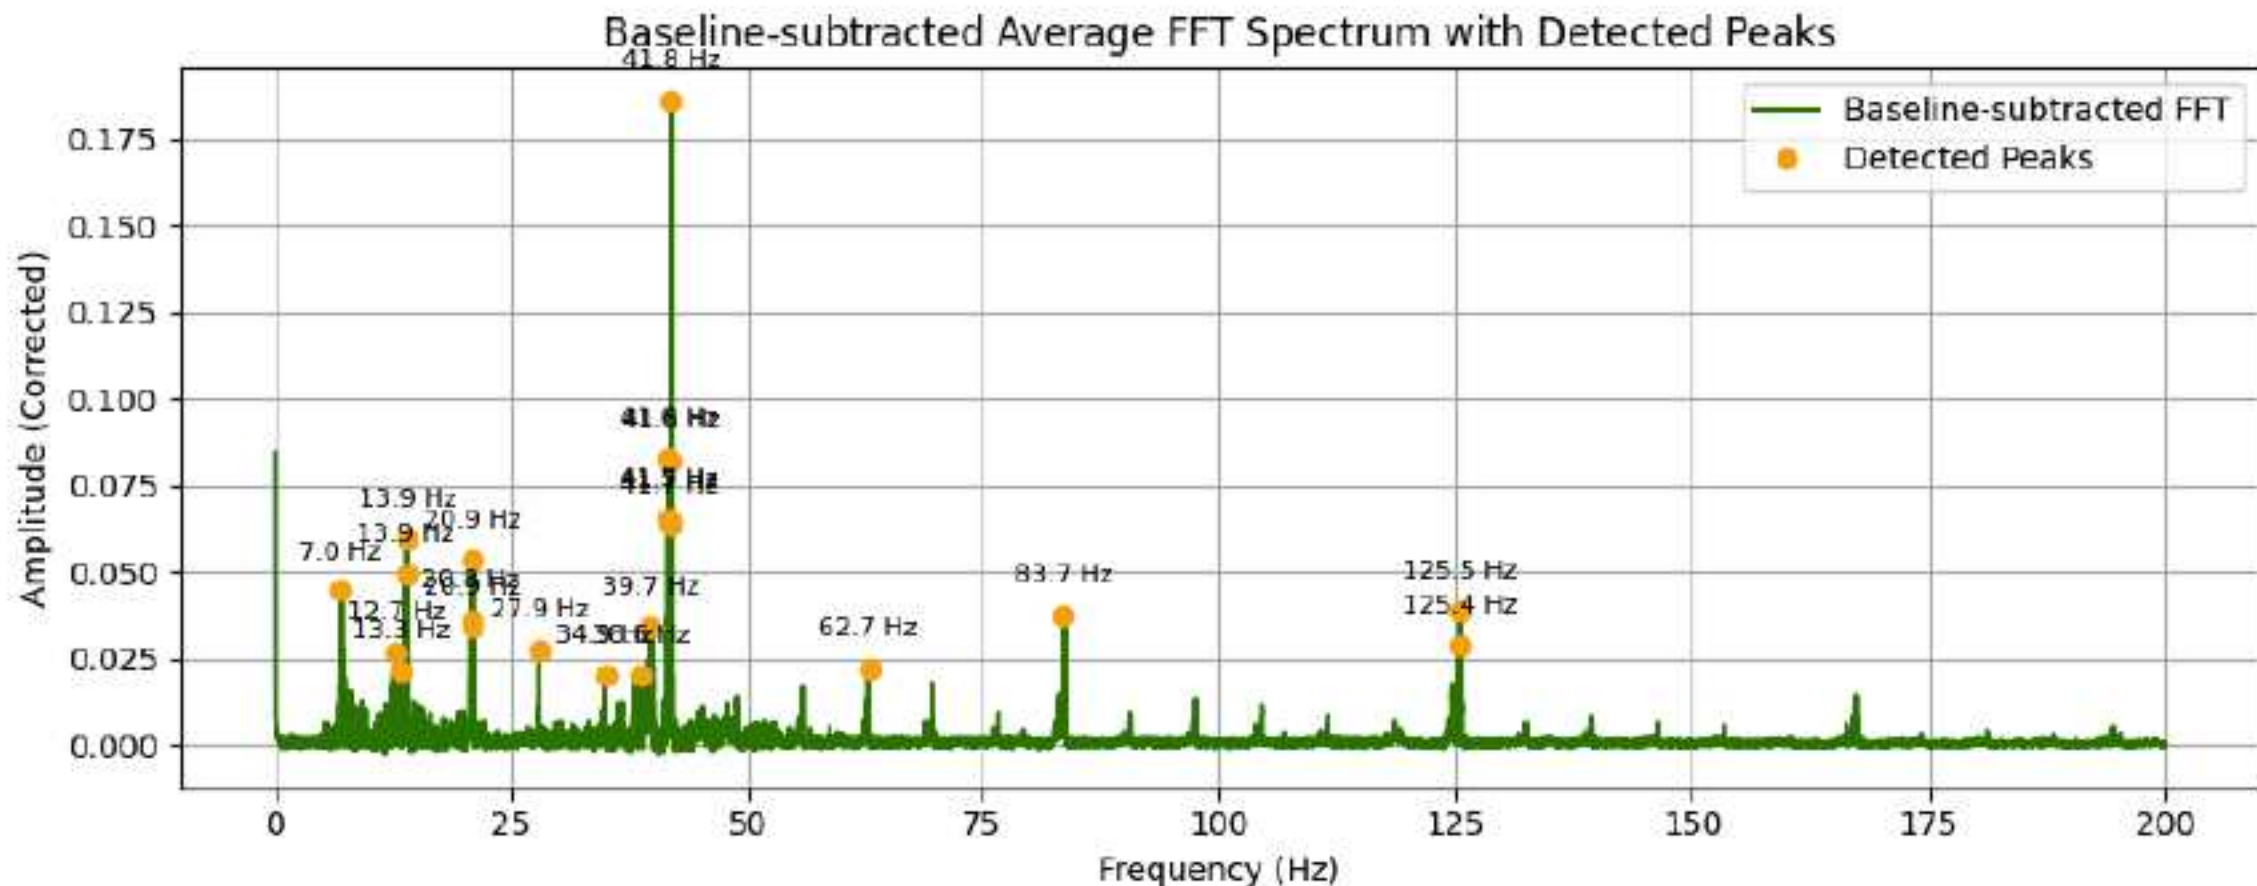
# Start-up: Integrated Spectrum

Main peak at 41.8Hz  
First Harmonic at 13.9Hz (800 rpm)  
Subharmonic 1:2 at 7.0Hz

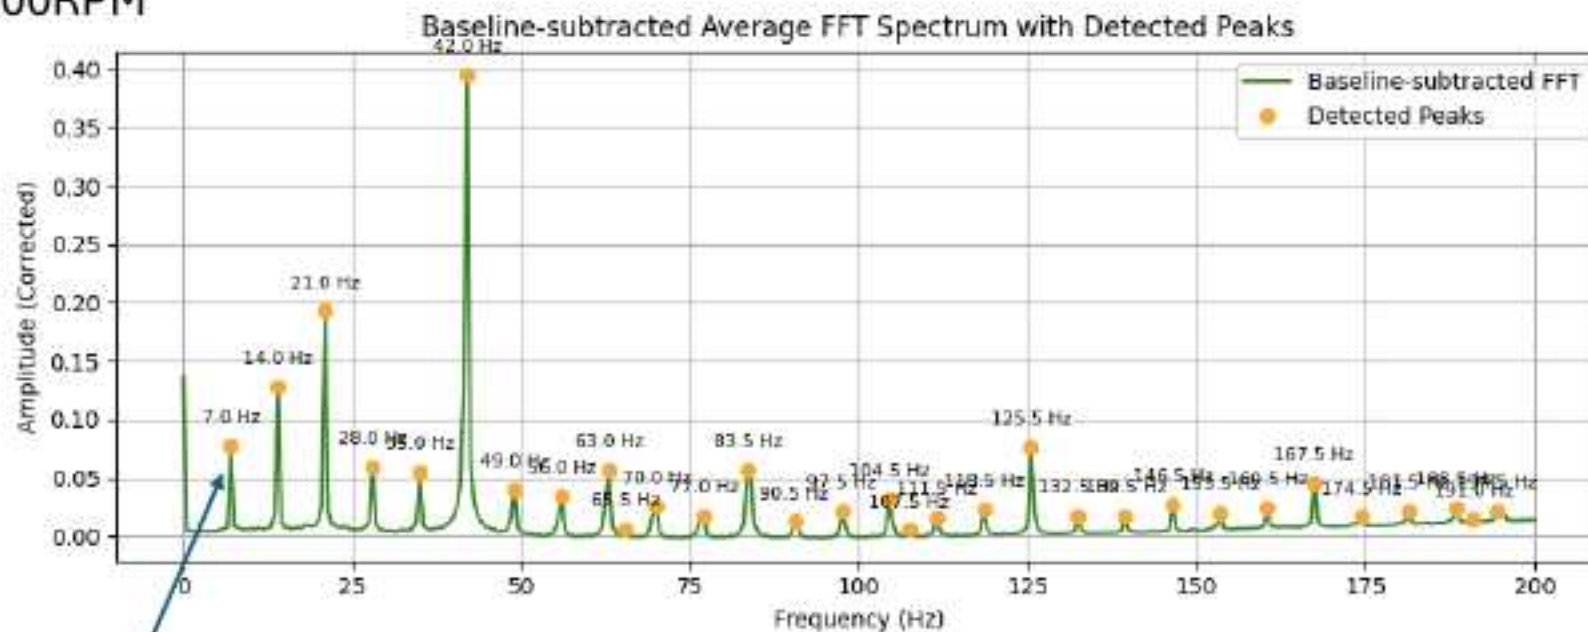
Motor ~800RPM

Subharmonic 1:2  
1 explosion every 2  
revolutions

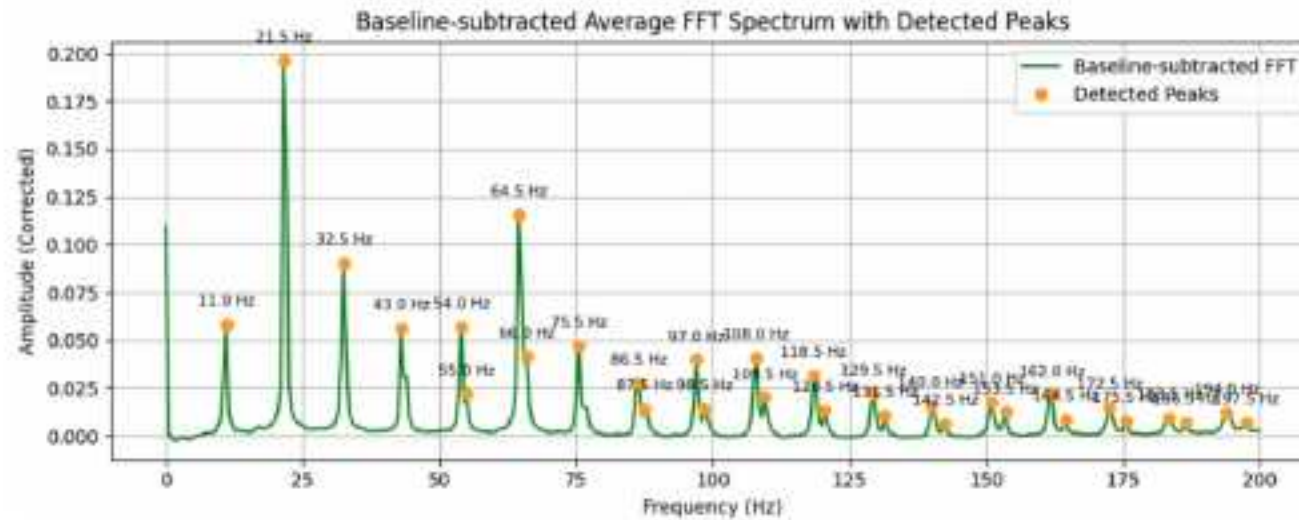
Engine ~1300rpm

There is a separation of the harmonics split into two series.

The separation seems proportional to the frequency

At 1300 rpm all harmonics (whole and  $\frac{1}{2}$ -orders) **split into two peaks**; the separation grows with frequency and each family has a **different spatial pattern**.

**Correlate** harmonic separation with torque and RPM measurements on both shafts (motor-generator / balancer shaft) to confirm the dual-source hypothesis.

Repeat tests under **different loads and governor settings** to evaluate the influence of hunting and torsional stiffness.

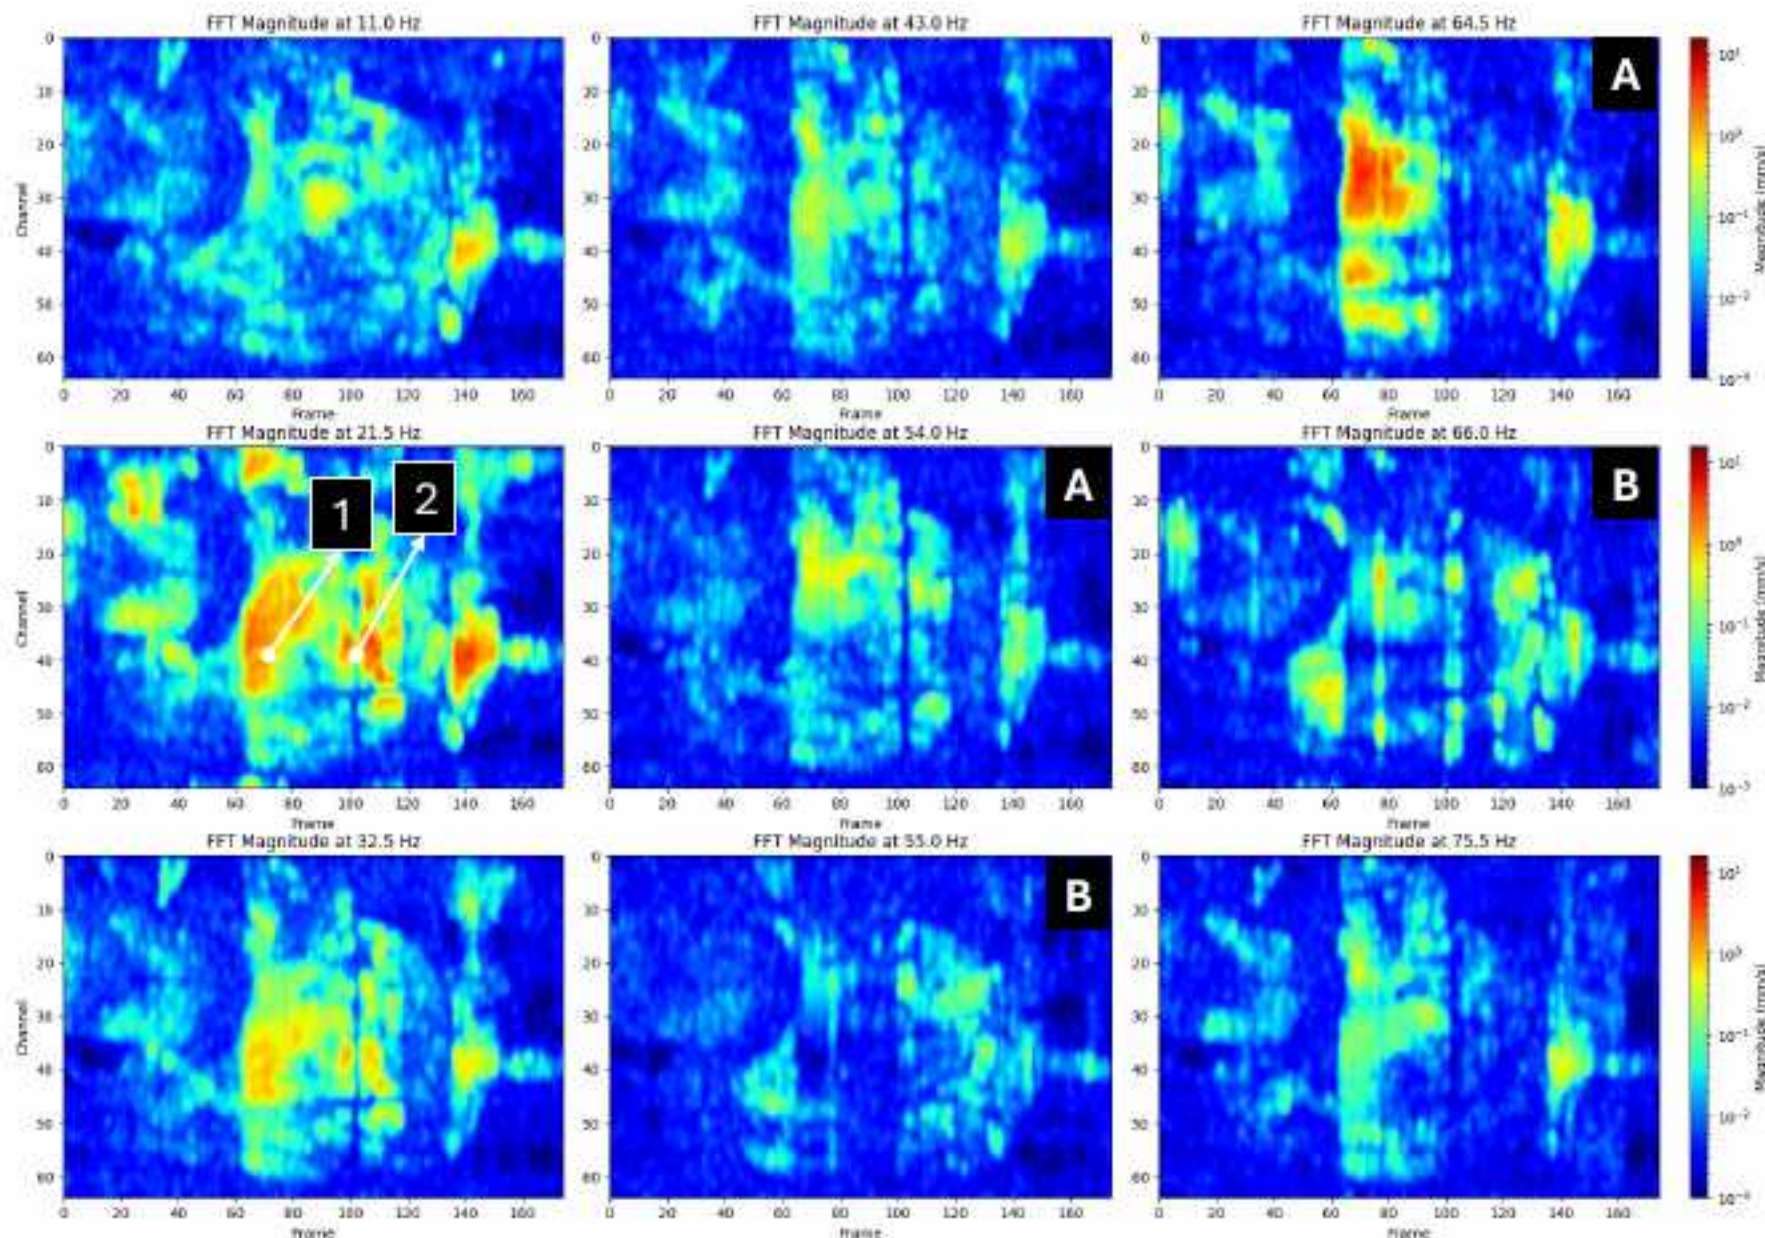
# Vibration Map (1300rpm)

Location of the series of frequencies A, B in pairs does not coincide spatially.

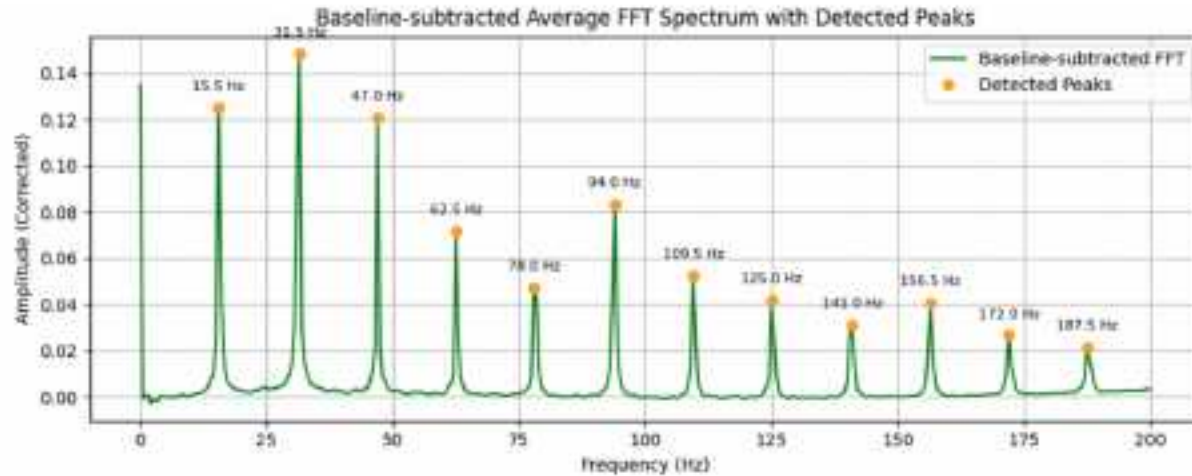
Engine ~1900rpm

The splitting observed at 1300 rpm disappears at 1900 rpm.

The splitting **disappears at 1900 rpm**, suggesting that the cause is associated with a torsional mode/coupling that goes out of resonance at higher speed.
